SERVICE BULLETIN REPLACEMENT OF THE PROPELLER GEARBOX FOR SOME ROTAX_® ENGINES TYPE 912/914 (SERIES) SB-912-056 UL SB-914-038 UL

JANUARY 09th 2008 Initial Issue Current valid documentation see: <u>www.rotax-aircraft-engines.com</u>

REPLACEMENT OF THE PROPELLER GEARBOX FOR SOME ROTAX_® ENGINES TYPE 912/914 (SERIES) SB-912-056 SB-914-038

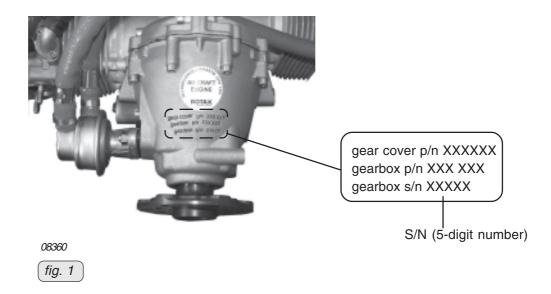
♦ NOTE: The relevant serial number of the gearbox is visible on the gearbox housing (see fig.1).

Due to a slightly increased amount of irregularity in the form of material inclusions some isolated problems were detected on the gearbox and/or the gear set in the field.

Such material inclusions in the area of the tooth base can lead to a tooth break under severe operating conditions.

Normally broken metal fragments are dropping to the lower portion of the gearbox and are retained captive by the magnetic plug, but in individual cases they may get squeezed by rotating gear sets further damaging the gearbox housing.

- 1. Lock the crankshaft
- 2. Remove the propeller gearbox. Perform relevant work depending on gearbox type in accordance with the current Maintenance Manual. The propeller gearbox needs to be sent to a ROTAX_® Authorized Distributor for repair.
- 3. Install the new propeller gearbox.
- 4. Restore aircraft to original operating configuration.
- 5. Connect negative terminal of aircraft battery.
- 6. Conduct test run including ignition check and leakage test.
- CAUTION: After the exchange of the propeller gearbox it is necessary to check the oil filter in accordance with the latest relevant Maintenance Manual (Line Maintenance, chapter 12-00-00).
