Service Bulletin

Installation of Starter Solenoid on CTLS with Large SLA Battery SB-ASTM-CTLS-16

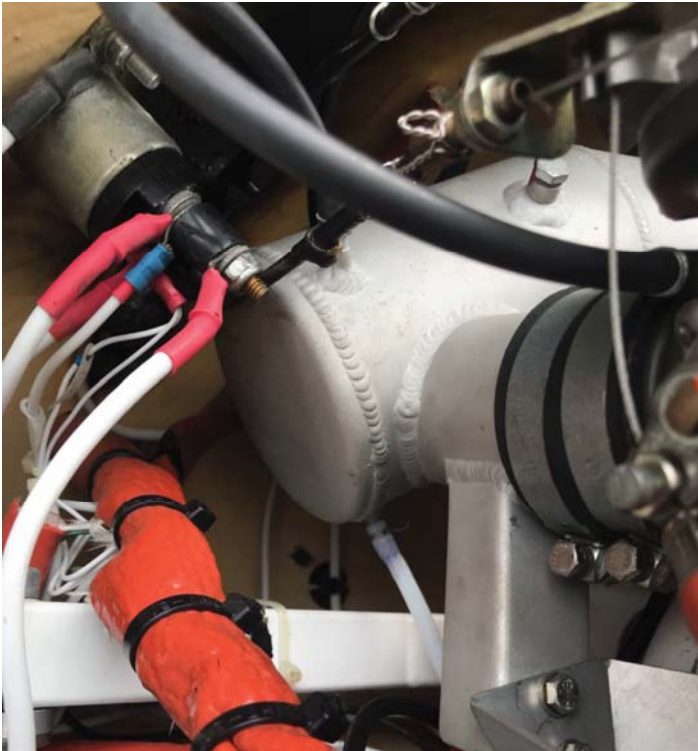
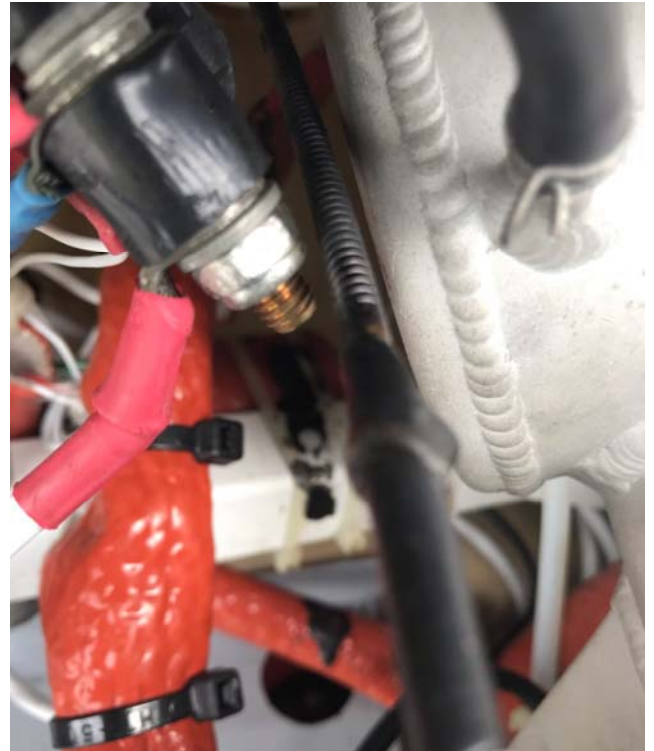
Some CTLS are equipped with a larger sealed lead acid battery. This requires a different location of the starter solenoid. Under certain unfavorable combination of tolerances, contact of the starter solenoid may contact the throttle cable housing, which in return gets worn through over time. An unprotected electric short circuit may be the result.

incorrect installation of starter solenoid, collision with throttle cable housing

This kind of misaligned installation should have been observed and corrected at the factory or during any annual condition inspection.

- Disconnect battery
- Detach solenoid from firewall
- Turn solenoid by 180 degrees (need to detach starter wiring temporarily)
- If needed prepare an adaptor plate to relocate the solenoid for correct distance to throttle cable housing.
- Properly attach solenoid and starter wiring.
- Reconnect battery.
- Close cowling.

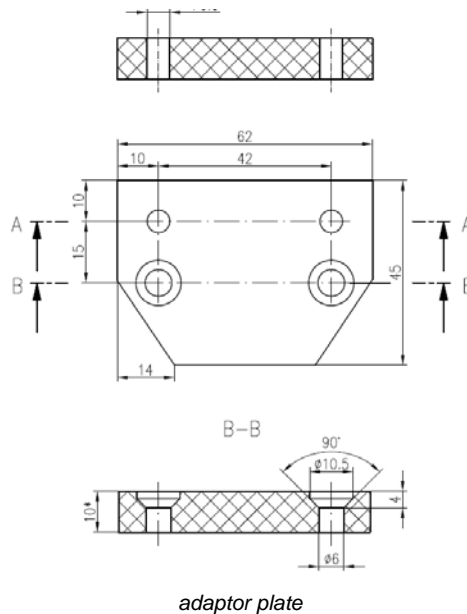
None-conductive material for preparation of an adaptor plate, if required, e.g. GFRP or phenolic material with thickness 7-10 mm (1/4-5/8 inch). Refer to the drawing below.

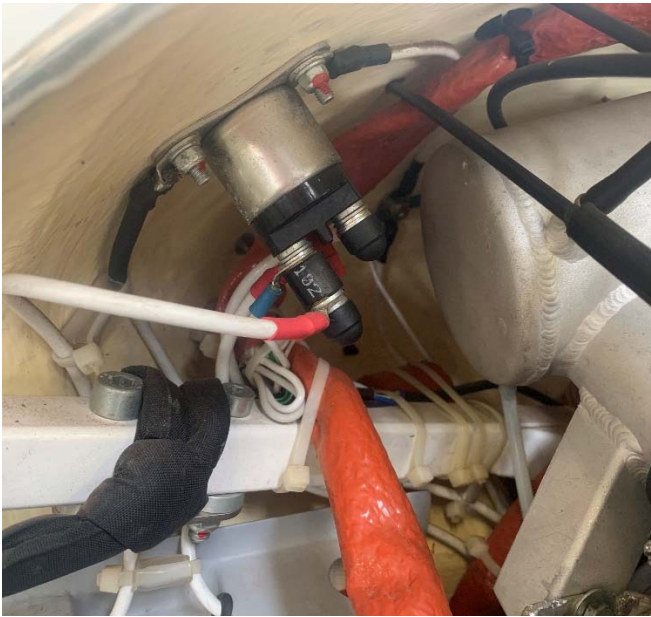
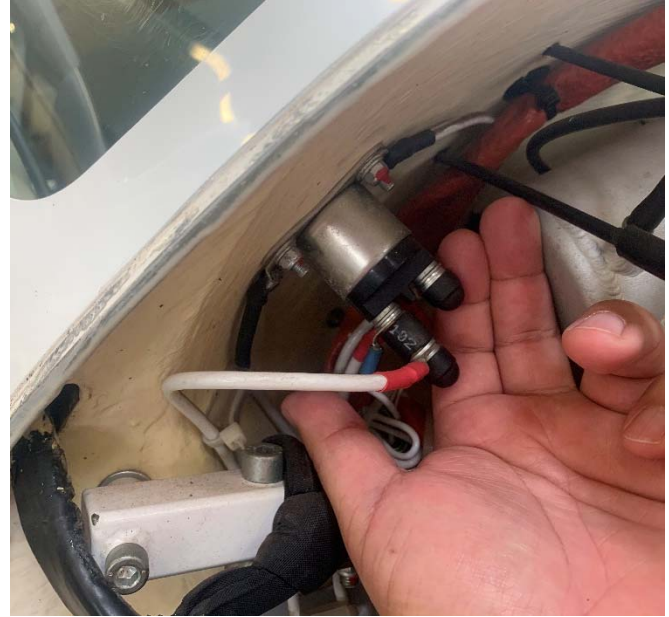
- Open the cowling
- Identify the throttle cable housing of the right carburetor
- Identify the starter solenoid
- Determine the distance between Bowden wire and contacts of the solenoid
- Distance should be at least 15mm-1/2 inch (a finger should fit in between)

correct installation of starter solenoid
